SERVICE BULLETIN

Loose Drive Axle Studs

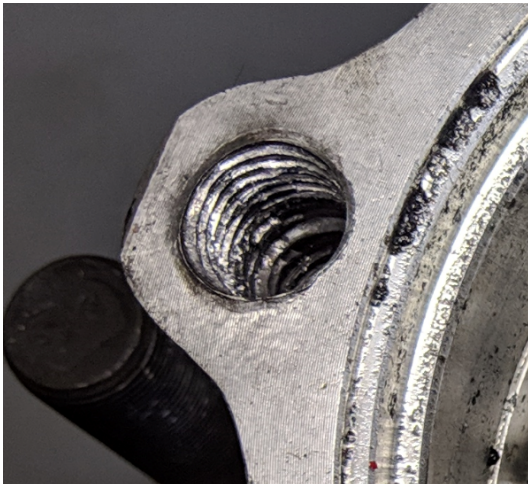
Figure 1 - Hub stud bore — Oblong hole, damaged threads, deformation of hub flange surface.

Hub damage or deformation like that depicted in Figure 1, and indicated by Figure 2 require hub replacement.

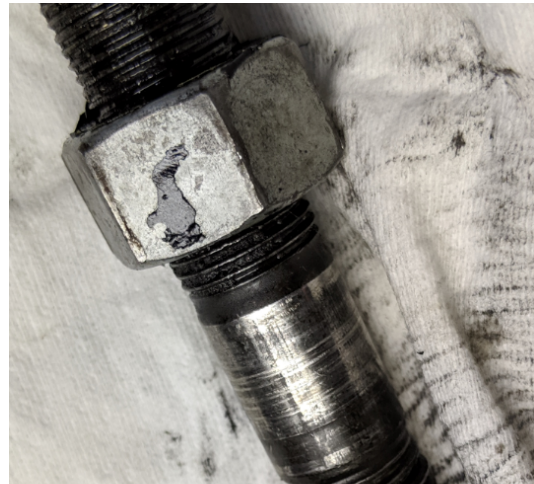
Figure 2 - Polishing of stud shank indicates loose joint. Separate any seized fasteners before reinstall.

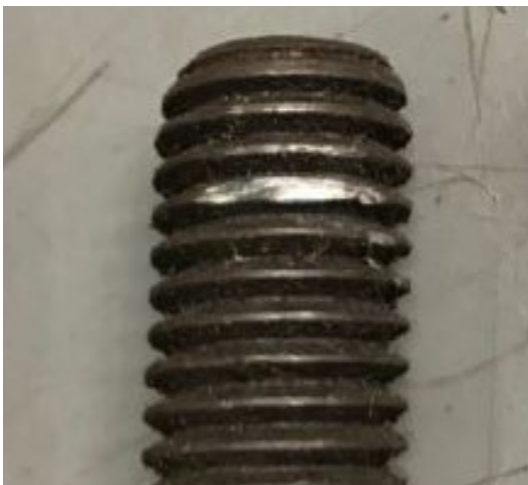
Figure 3 - Deformation of stud threads

Damage to a stud requires stud replacement.

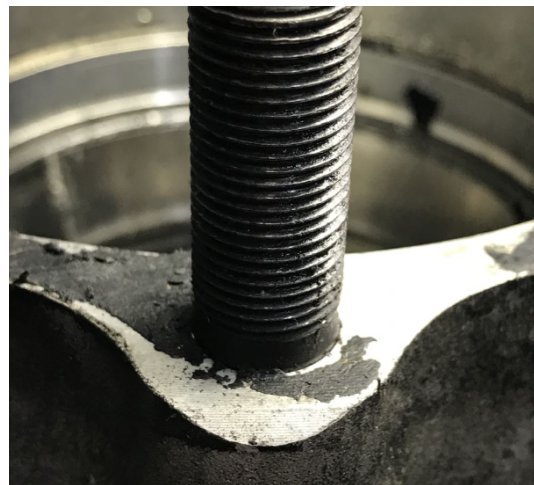
Figure 4 - Clean any dirty stud threads or gasket material from the hub & flange mating surfaces.
